## CASE STUDY

CLIENT: **Anglian Water**

Site: **St.Osyth STW**

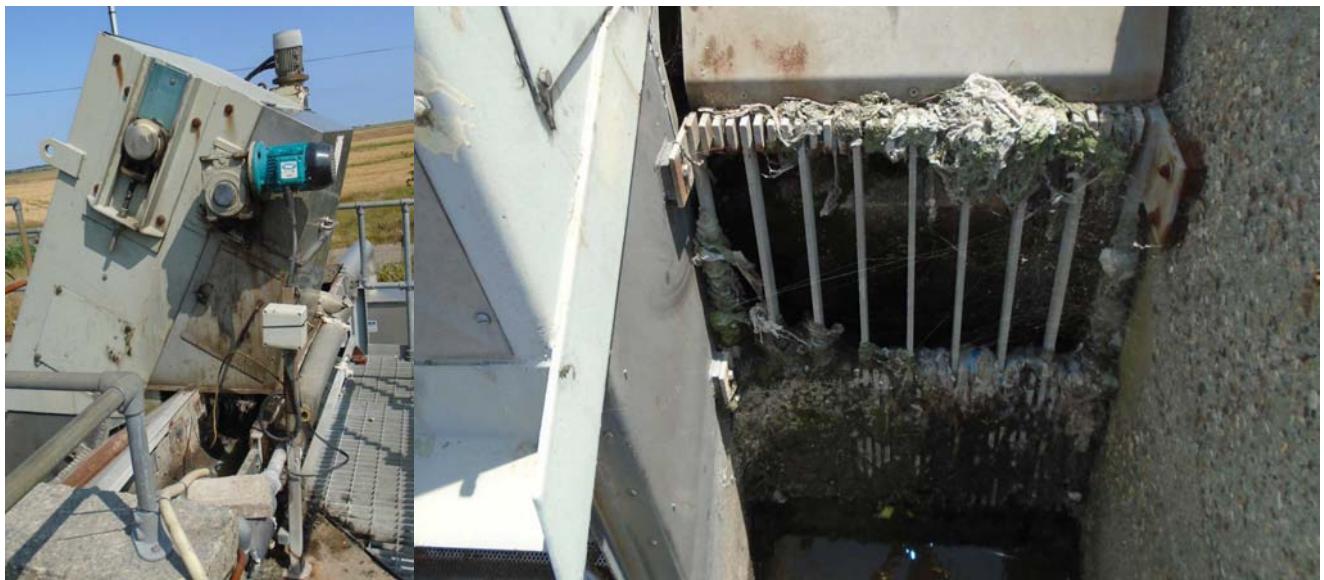
Initial on-site inspection found evidence of extensive age related damage, deeming it necessary to remove the screen to M&N's dedicated workshop for immediate repair.

To ensure no downtime to operations at the works, M&N provided a dedicated hire unit that was rapidly deployed to site so removal of the damaged screen could proceed without further delay.

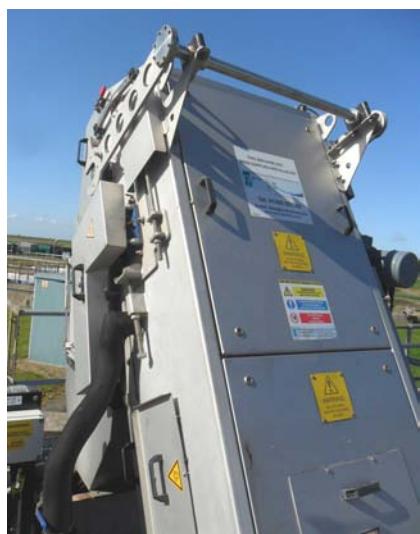
**A Frankenberger FSM Escalator Screen** was selected to meet both operational and budget targets. M&N's project team set about analysing site layout and existing infrastructure to develop a comprehensive installation sequence.

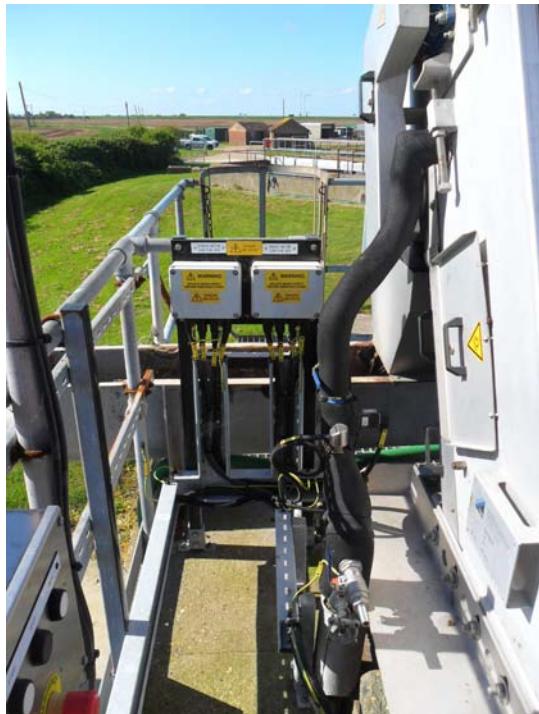
- Modifications made to the original weir plate
- New screen adapted to retrofit to existing launder channel and Hand Rake
- New wash water pipe work installed

- Electric safety features updated
- Existing Control Panel updated with new back plate & control door
- 3m high gantry widened and new concrete piers constructed to accommodate new screen
- Clear access point to rear of screen created
