CASE STUDY

CLIENT: **Anglian Water**

Site: **Shillington STW**

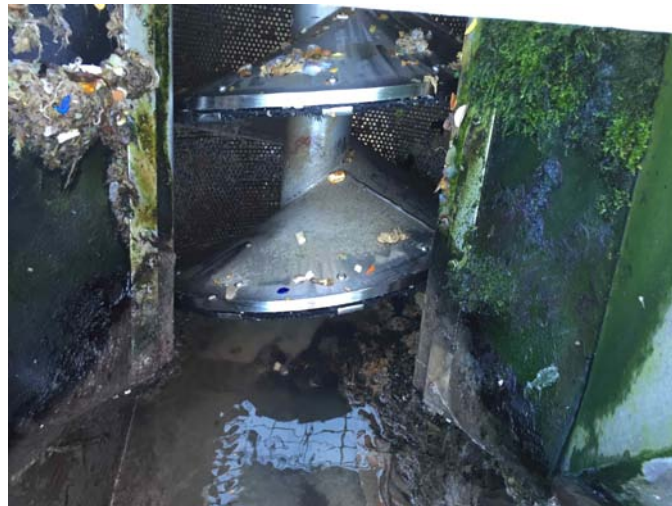
- Existing (non-M&N) brush screen failing consistently due to age and wear

1. The existing brush screen had deteriorated to a point whereby it was considered beyond economical repair.
2. Opening up of the inlet channel to remove restrictions of 6 inch inlet points would create more manageable flow of liquid to screening unit, minimising backwash potential.
3. Improvements to screen layout and access could be incorporated during the installation.

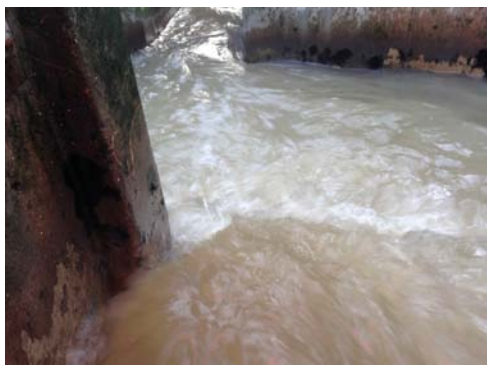
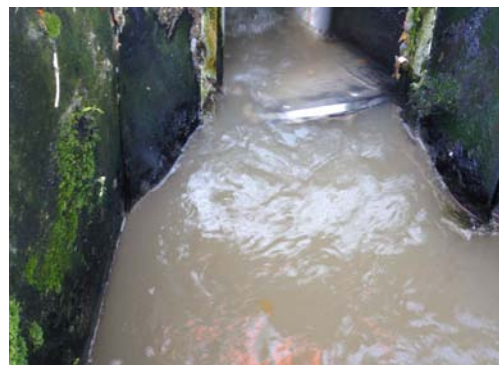
- Significant resultant backwash due to screen failure

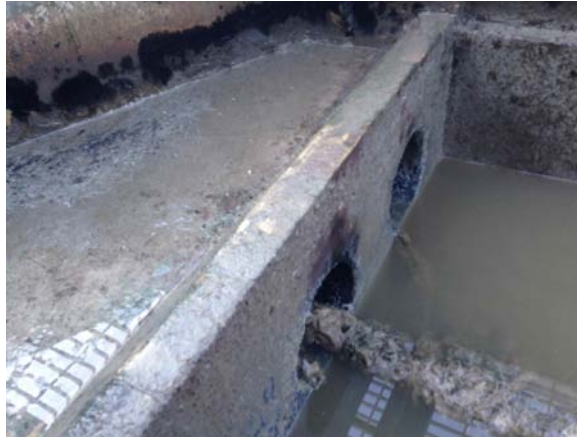
- Heavy flow to bypass channel further hampered by restrictive 6-inch concrete inlet channel infrastructure

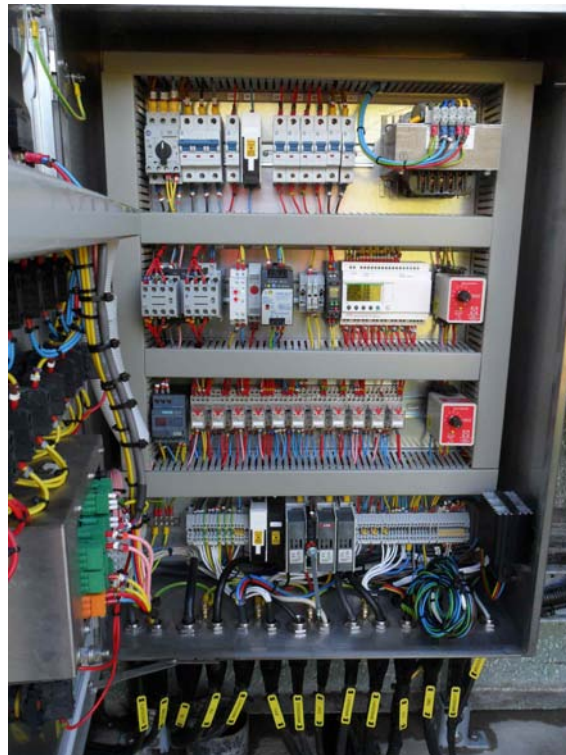
MNSS5 retro-fitted to existing STW infrastructure alongside new Control Panel with telemetry capabilities.

M&N's dedicated electrical control panel team fabricated a bespoke state-of-the-art unit to control all aspects of the MNSS5's functionality, including the modifications detailed by the technical team.
